ADEQ Final Determination (1980's Rule), - Alvord Park Lake AZL15060106B-0050

ADEQ Final Determination (1980's Rule), - Big Creek AZ15050201-312

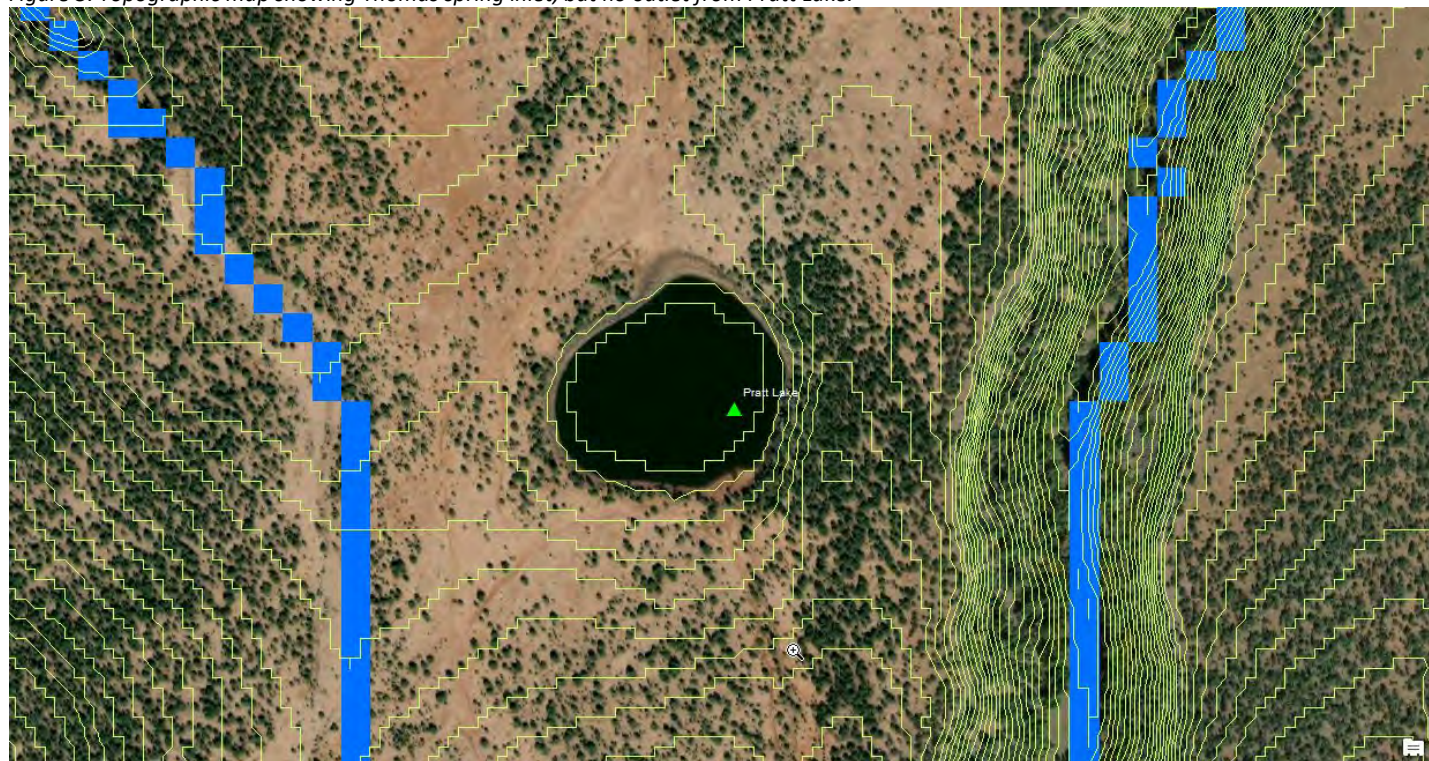
Figure 4. NED 2m contours analysis; image showing no outlet from Pratt Lake.

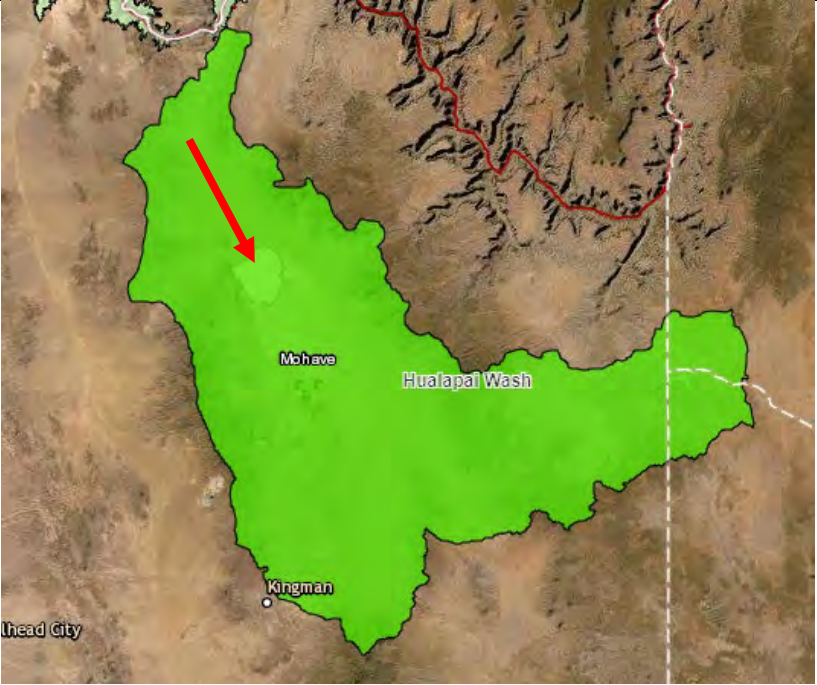
<p>Figure 1. Red Lake lies within the Hualapai Wash terminal basin (ADEQ WOTUS Webmap)</p>

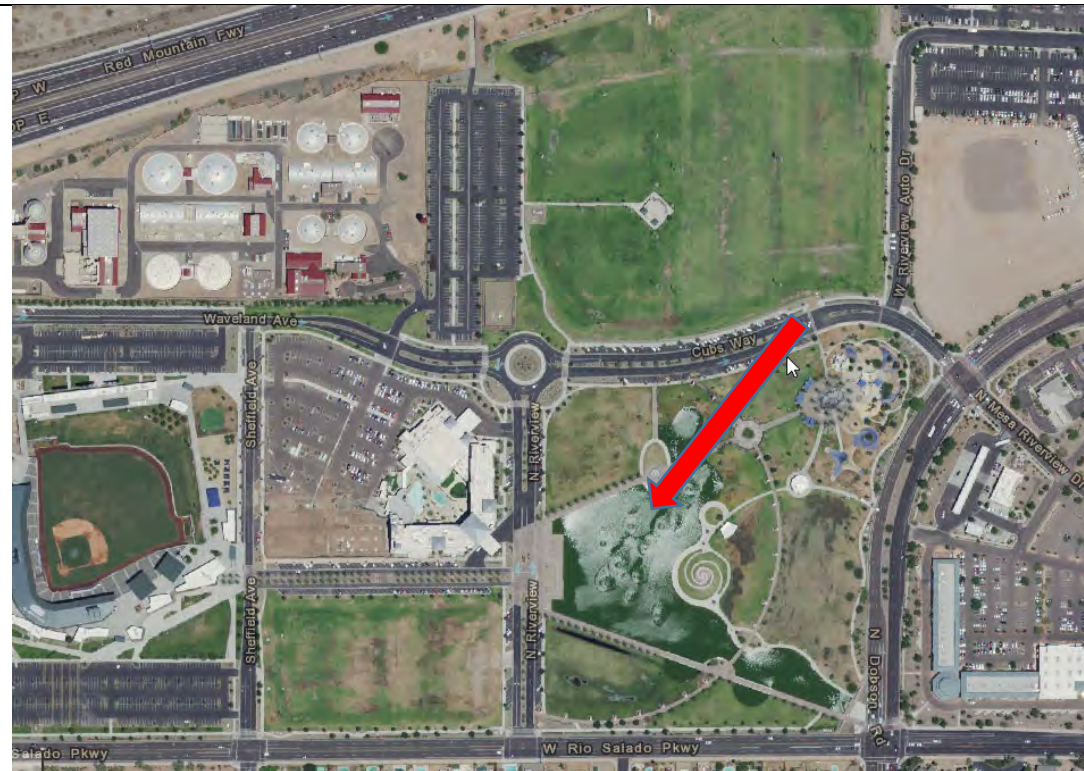
Figure 1. Riverview Park and surroundings; no inlet or outlet visible.

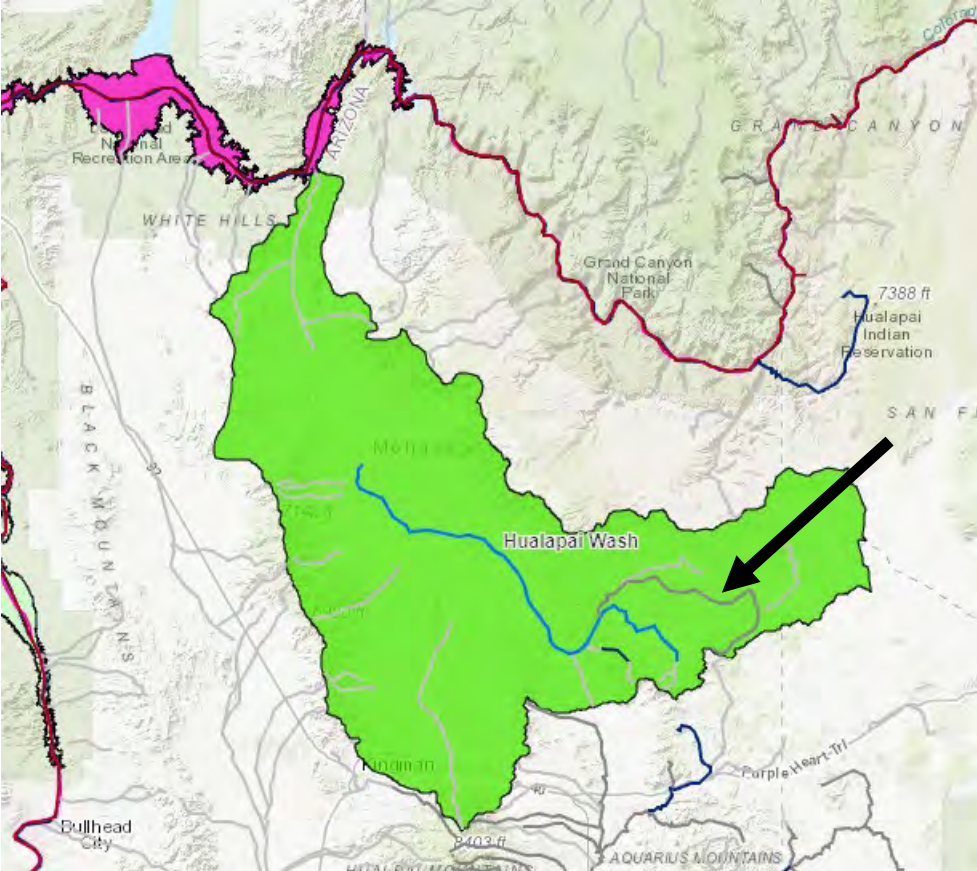
<p>Figure 1. Rock Canyon (designated with an arrow) lies entirely in the Hualapai Wash terminal basin.</p>

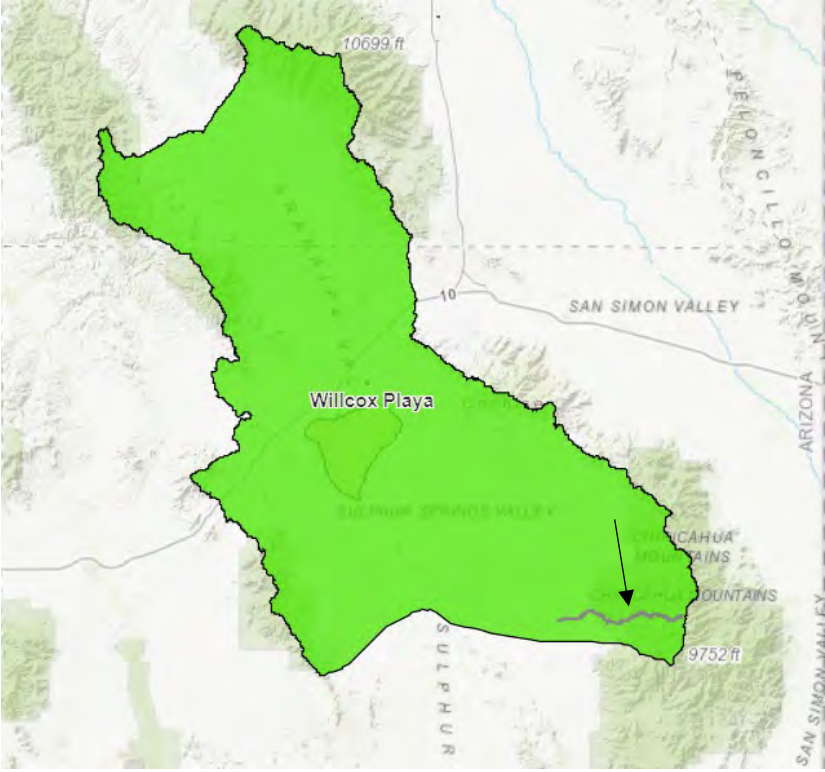
<p>Figure 1. Rock Creek (designated with an arrow) lies entirely in the Willcox Playa terminal basin.</p>

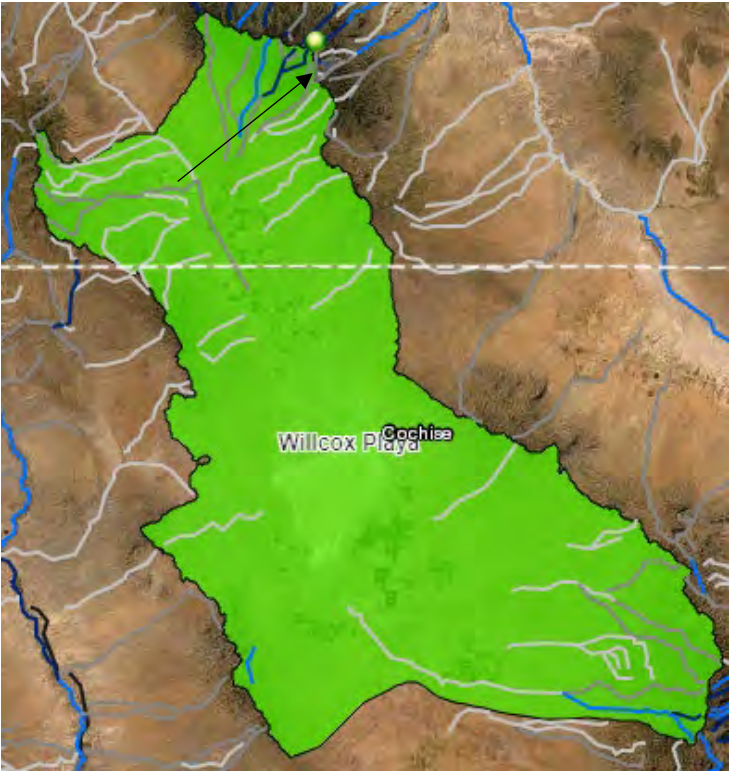
<p>Figure 1. Location indicated with an arrow, Snow Flat Lake is located within Willcox Playa terminal basin.</p>

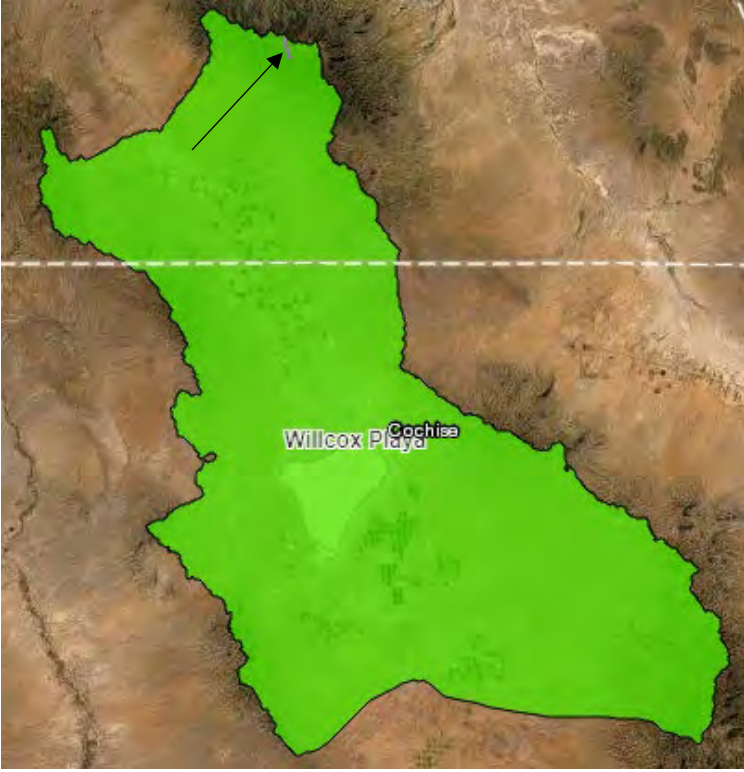
<p>Figure 1. Soldier Creek (designated with an arrow) lies entirely in the Willcox Playa terminal basin.</p>

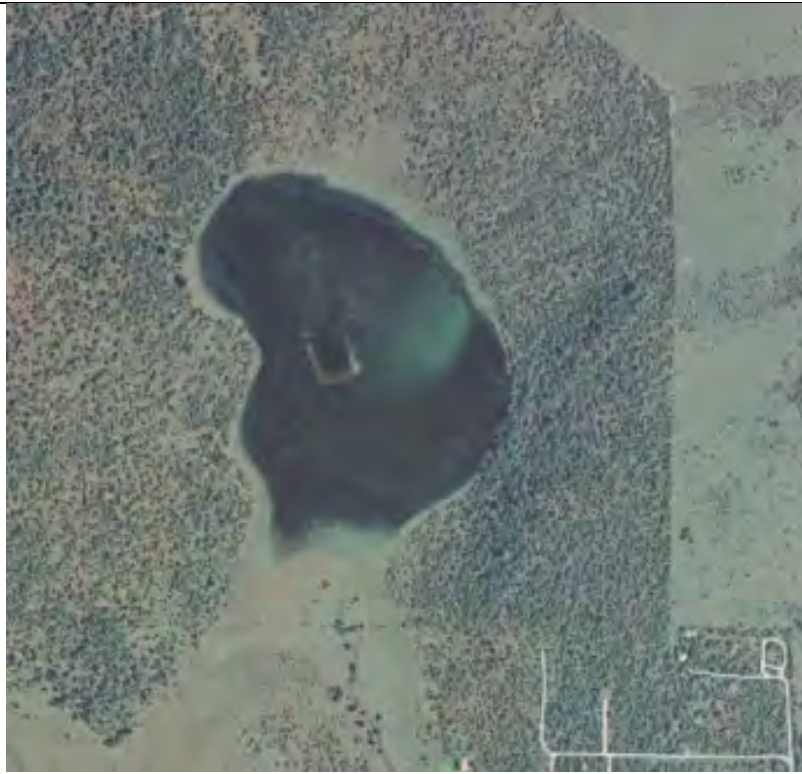
Figure 1. Aerial imagery shows that Sponseller Lake does not have visible channels or outlets.

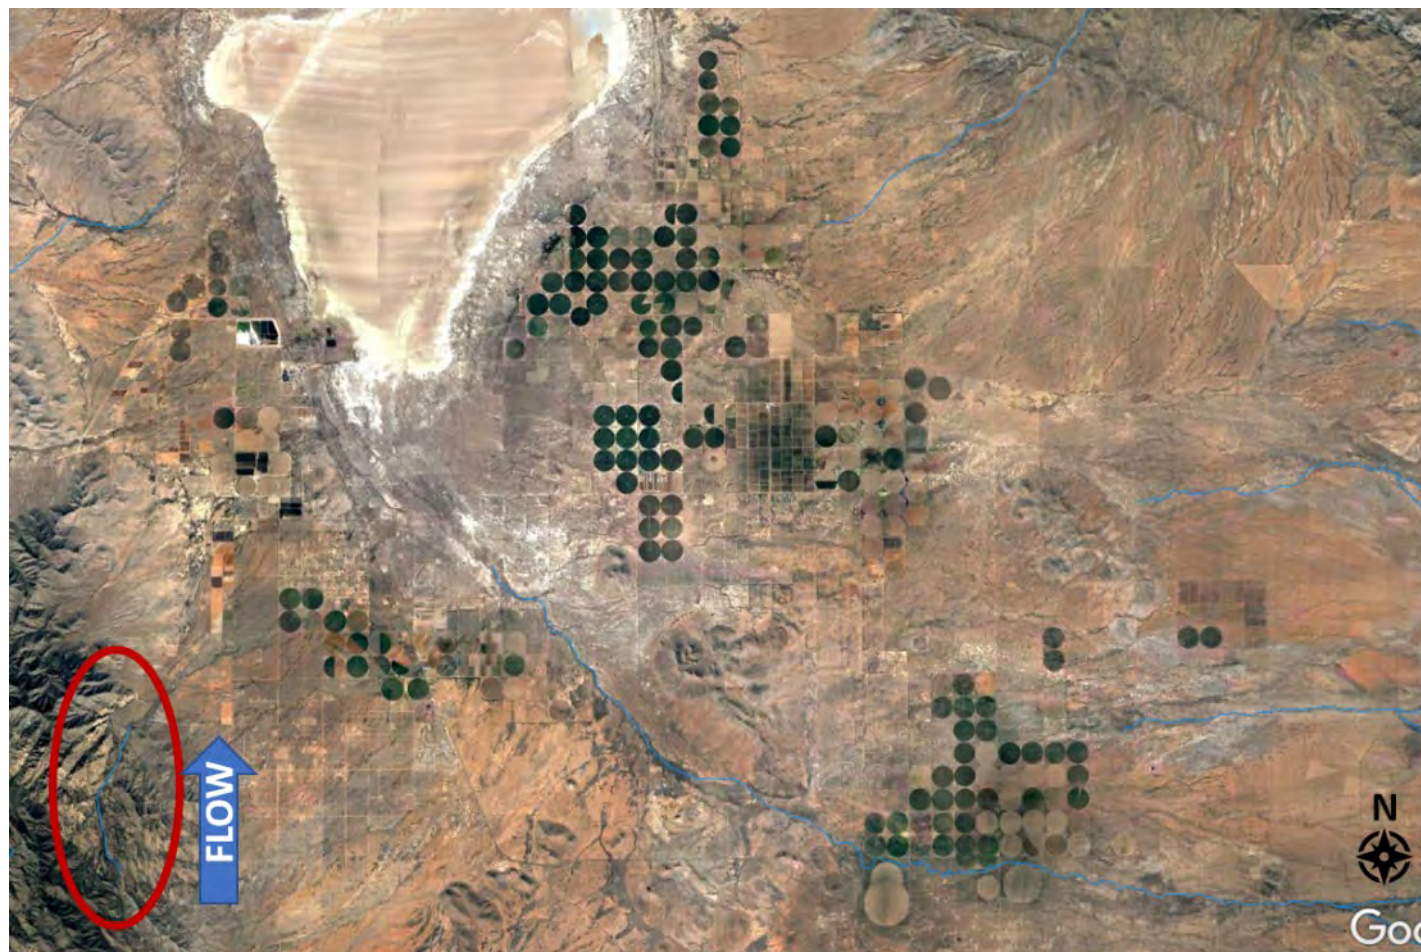
Figure 1. Stronghold Canyon flows north east towards Willcox Playa

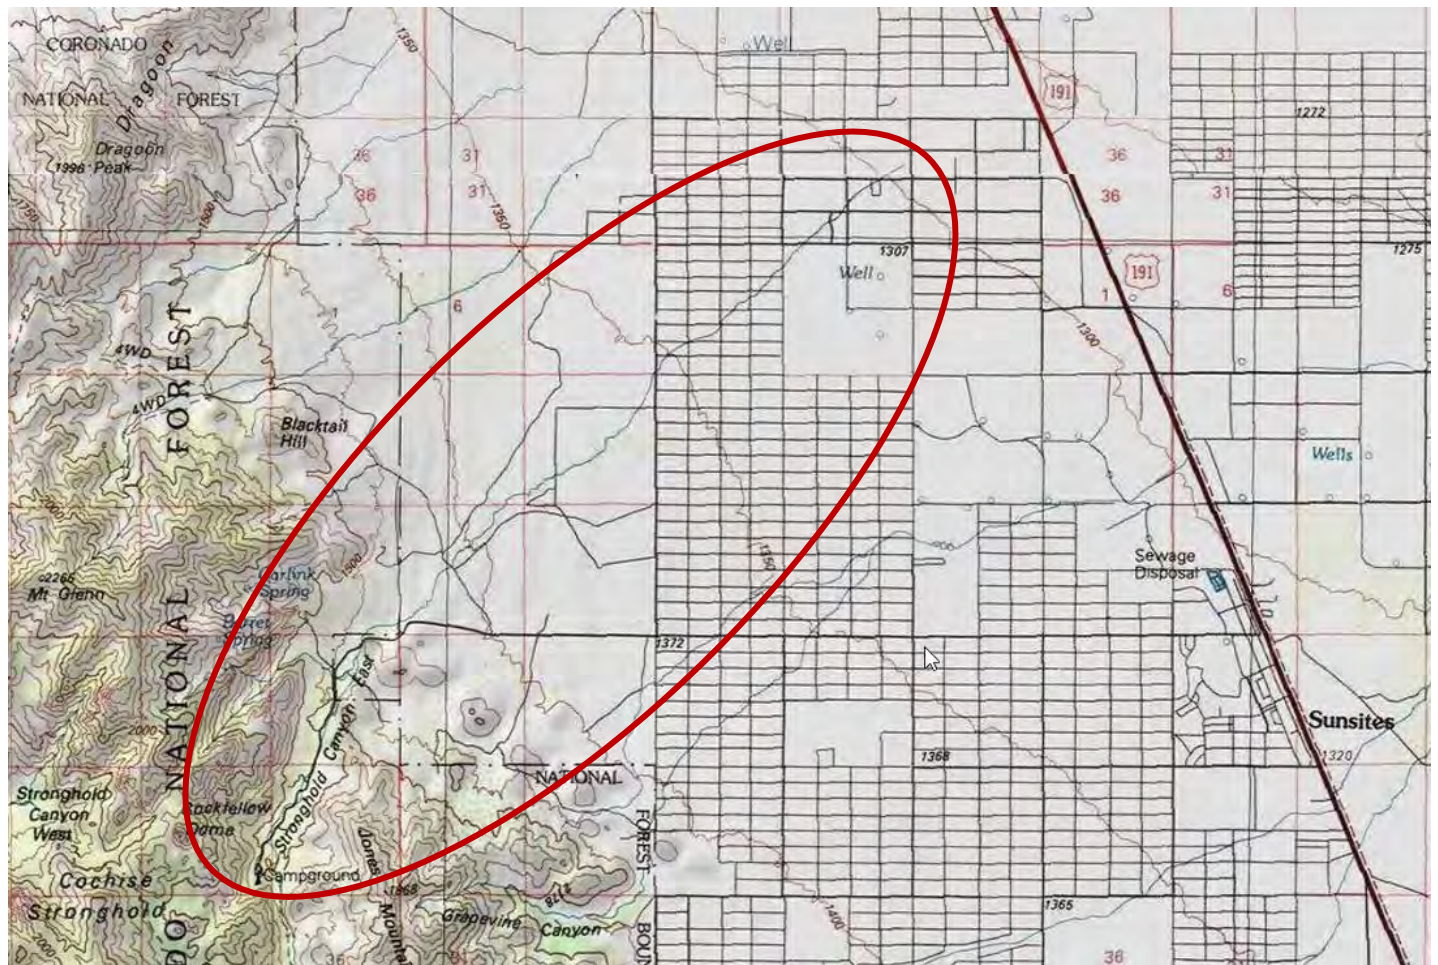
Figure 4. Topo map showing Stronghold Canyon (east) flowing from the Dagoon Mountains and disappearing on the alluvial plain before reaching Willcox Playa.

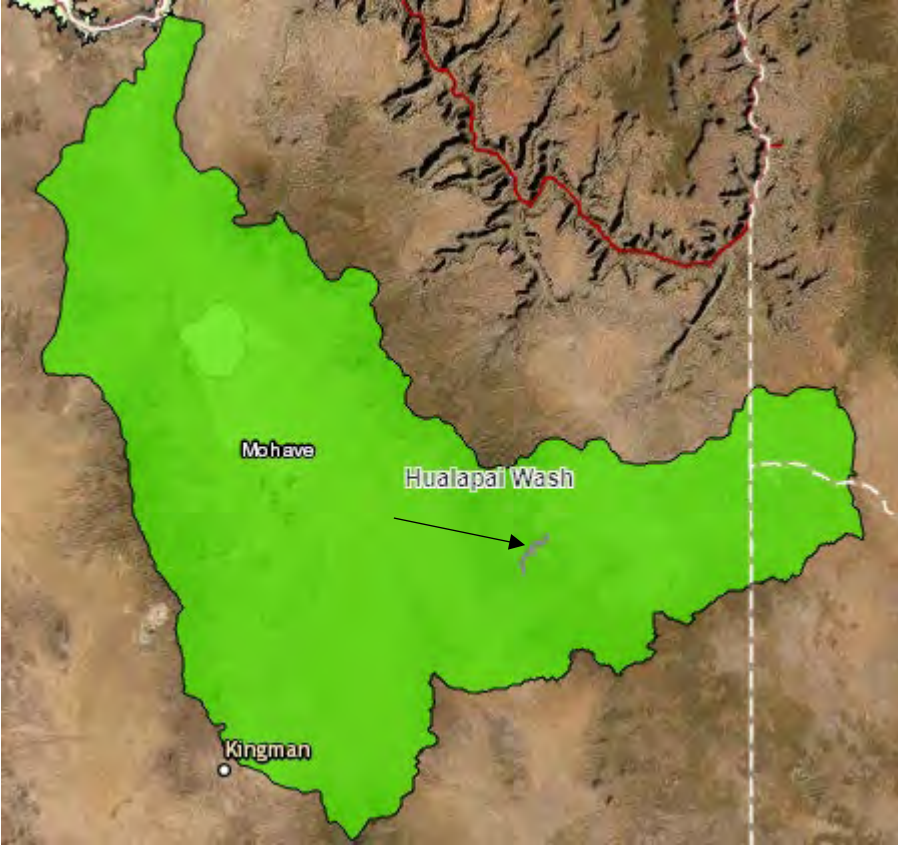
<p>Figure 1. Truxton Wash (designated with an arrow) lies entirely in the Hualapai Wash terminal basin.</p>

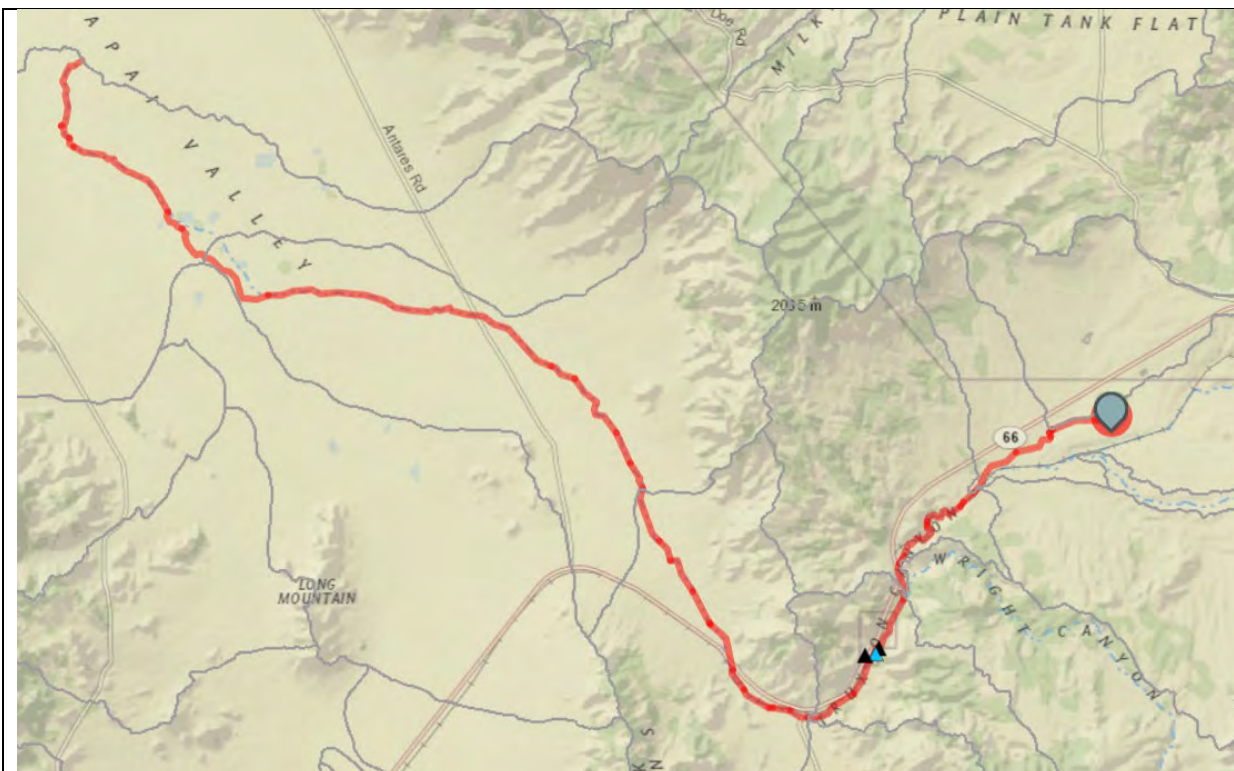
Figure 2. USGS Raindrop tool shows no connection to a TNW and terminates within Hualapai Wash Terminal Basin.

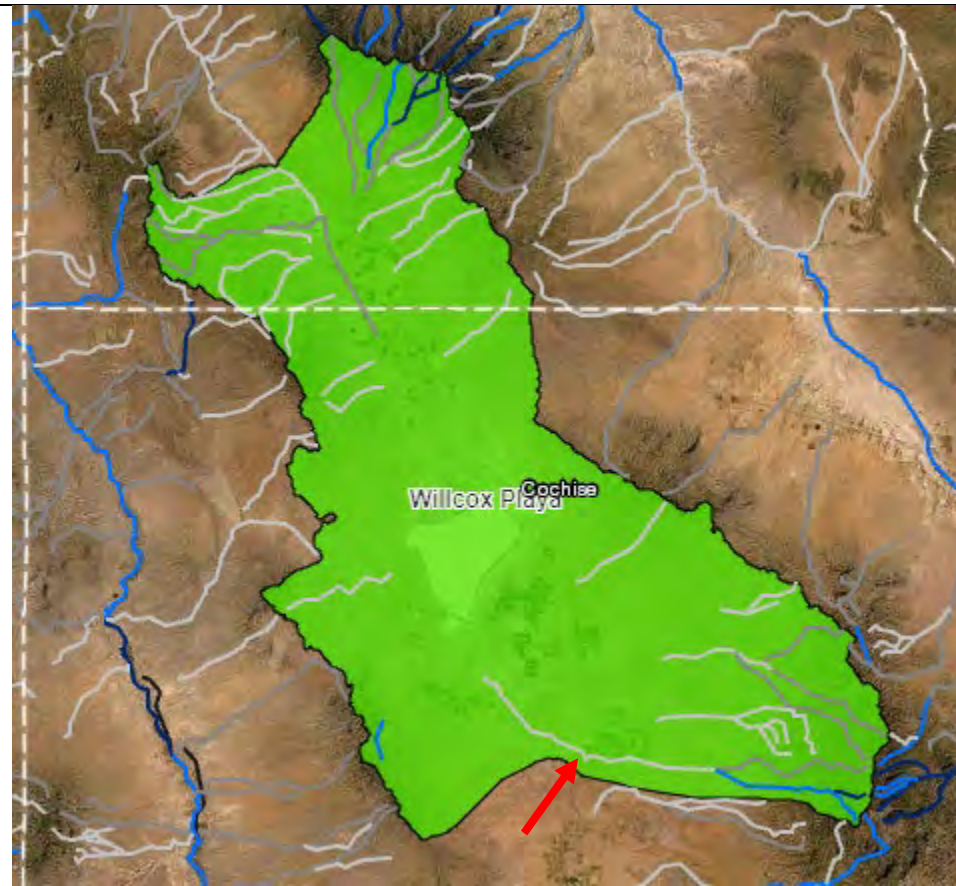
Figure 1. Aerial imagery from the WOTUS Webmap with the Terminal Basins Under the 1980s WOTUS Rule layer turned on shows that Turkey Creek lies entirely within the Willcox Playa terminal basin.

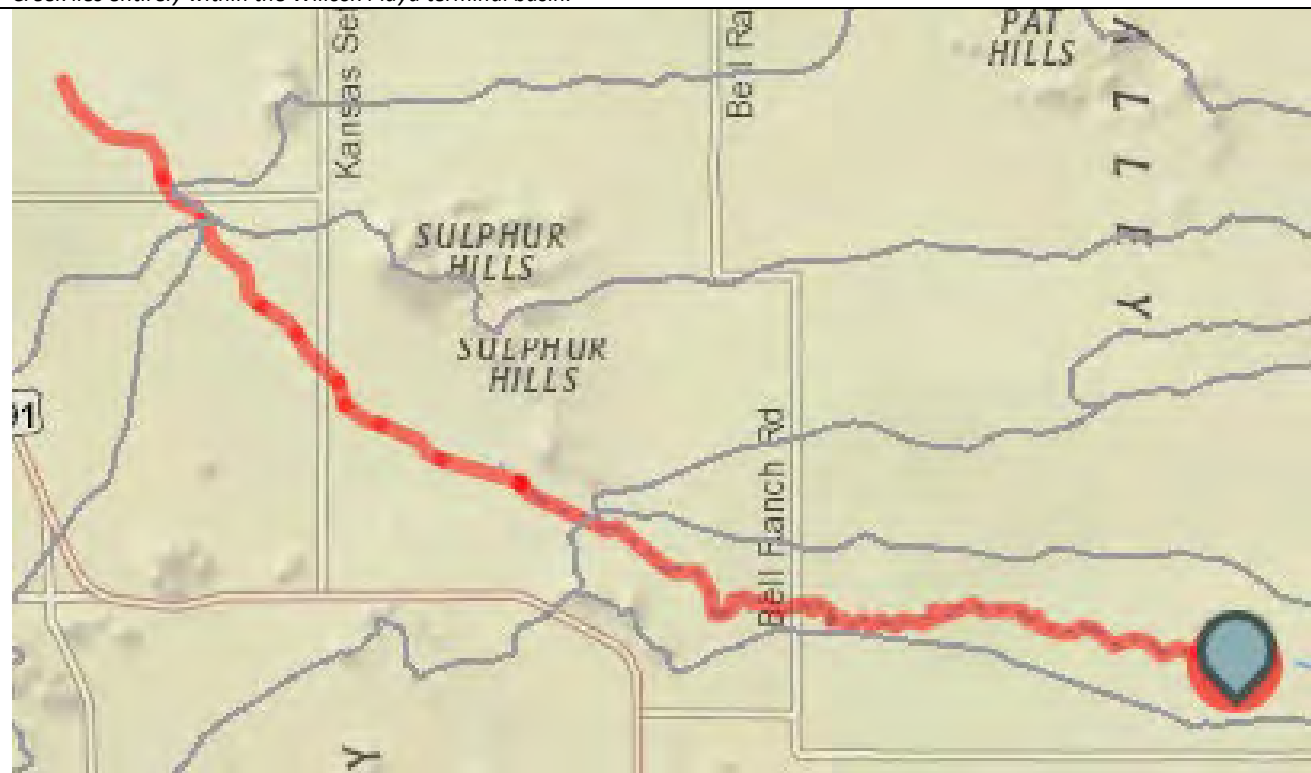
Figure 2. The Raindrop Tool from USGS traces a flowpath that terminates in the Willcox Playa terminal basin and before reaching a TNW.

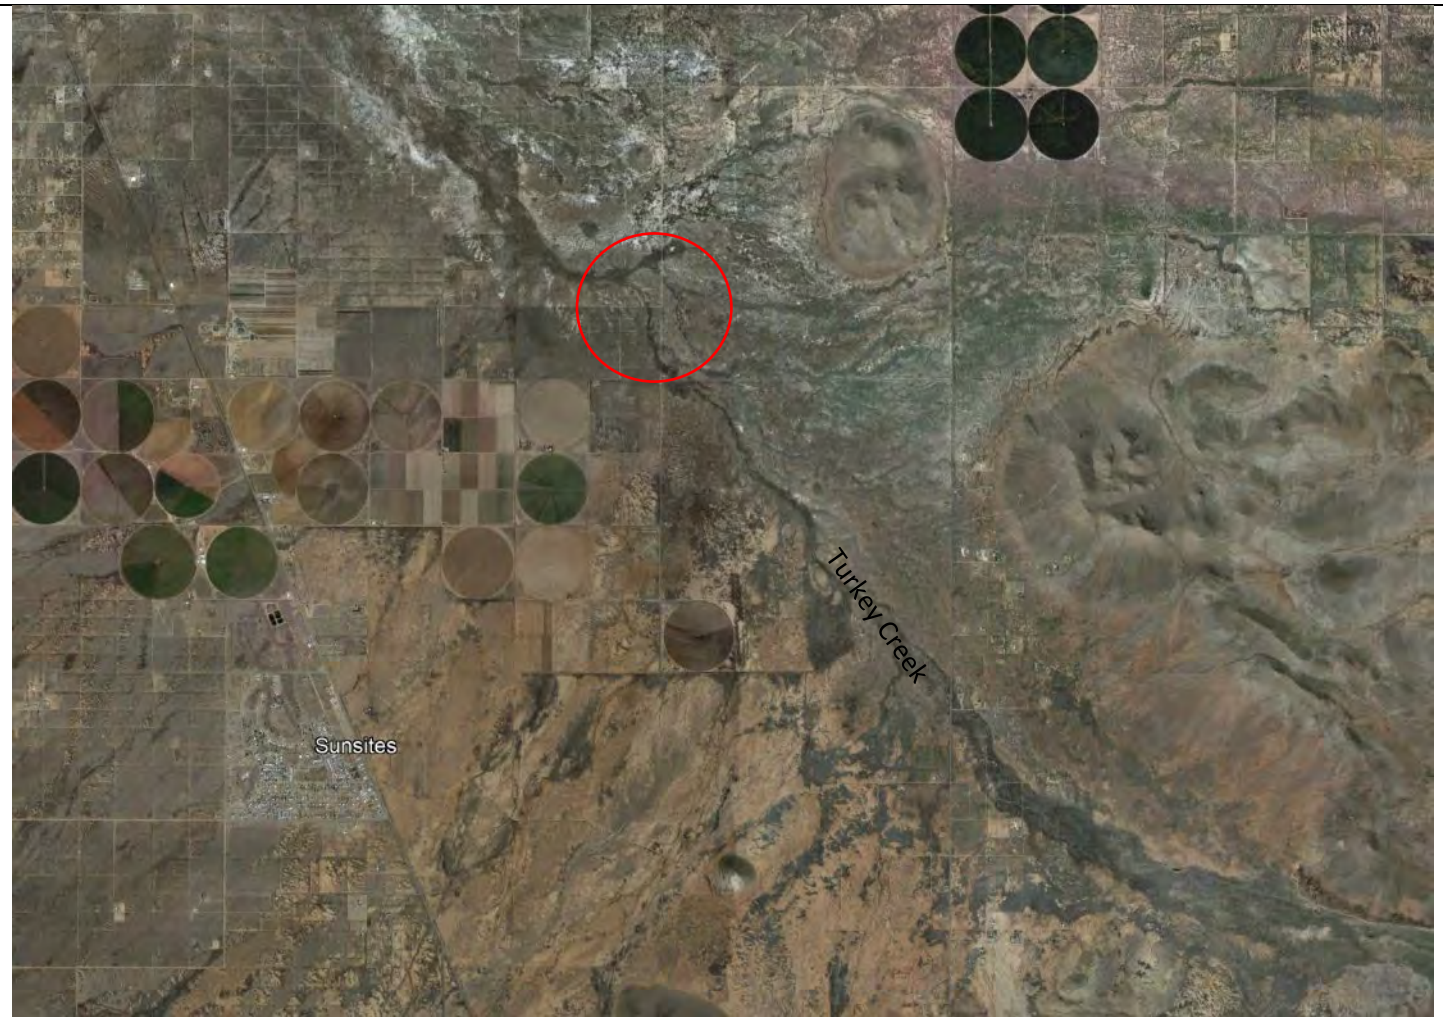
Figure 3. Google Earth Pro Imagery (2021) showing terminus (red circle) of Turkey Creek (15050201-002B).

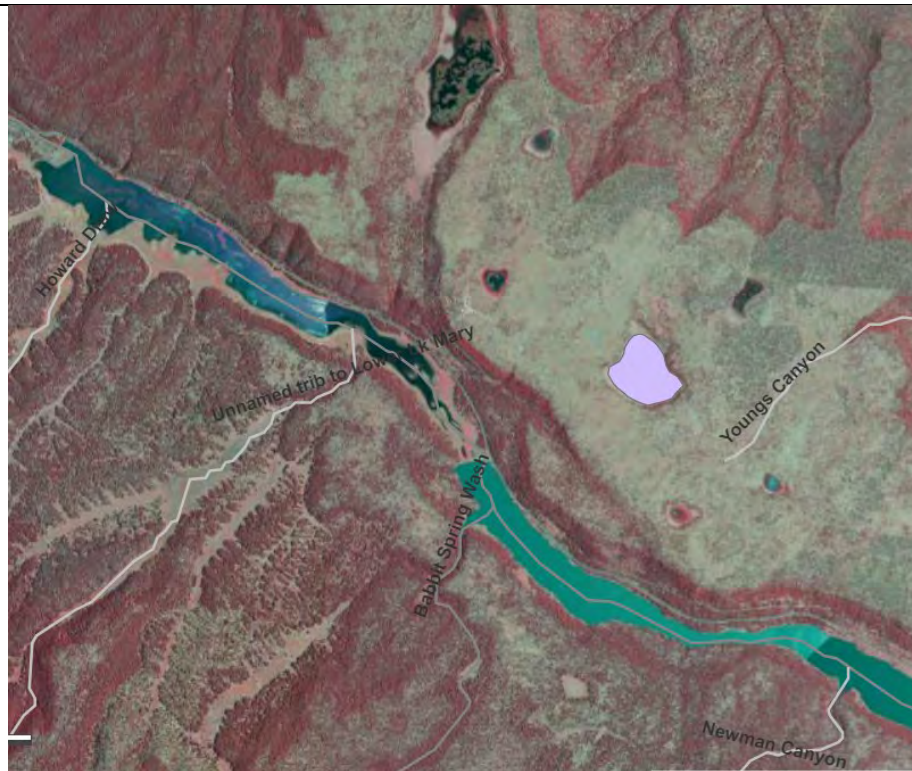
Figure 1. WOTUS Webmap NAIP 2017 imagery showing Vail Lake (in purple) with proximity to waterbodies Newman Canyon, Youngs Canyon, Babbit Spring Wash, Unnamed Trib to Lower Lake Mary, and Howard Draw.

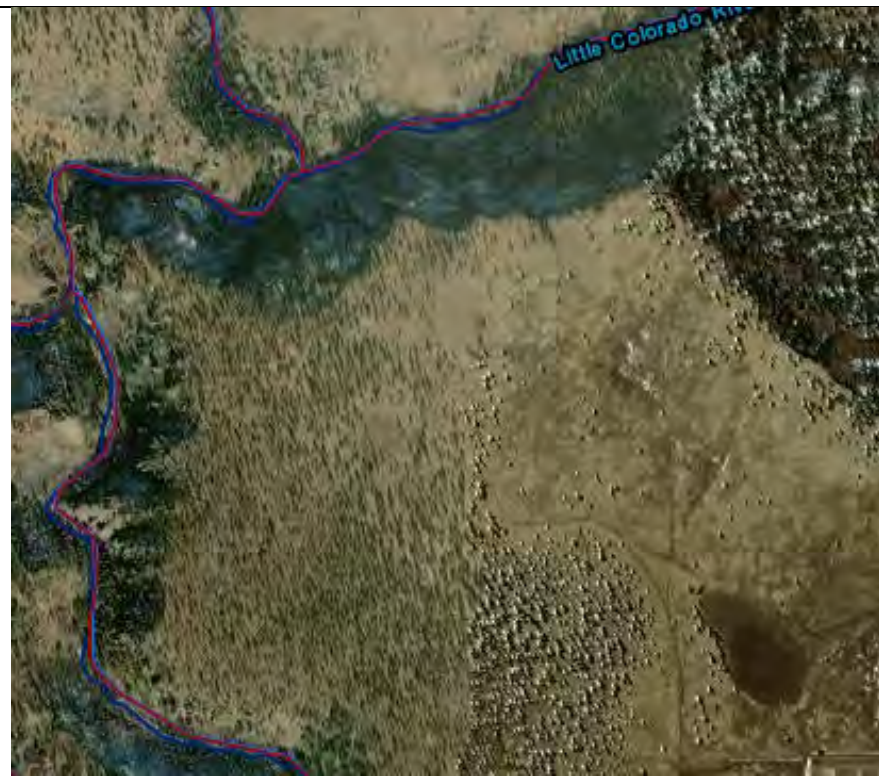
Figure 1. Aerial imagery of Water Canyon Reservoir (bottom right) with the NHD and flow regime layers of the WOTUS Webmap turned on. No channels providing connectivity from Water Canyon Reservoir to the Little Colorado River are visible .

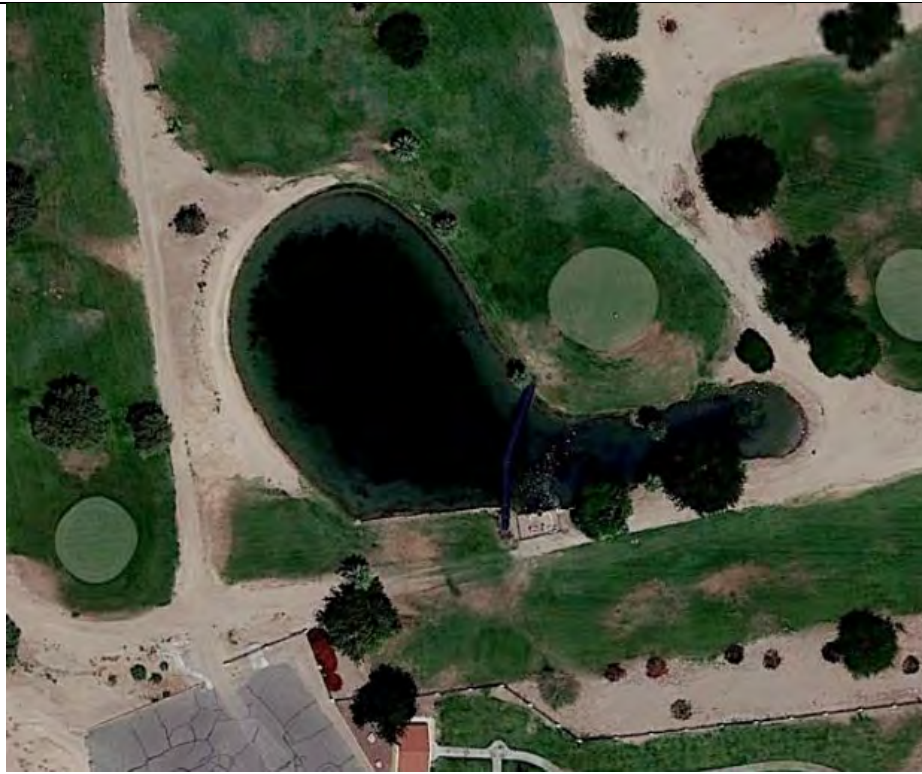
Figure 1. Google Earth imagery showing Wellton Pond 1 located within Butterfield Golf Course. There are no visible channels or outlets present.

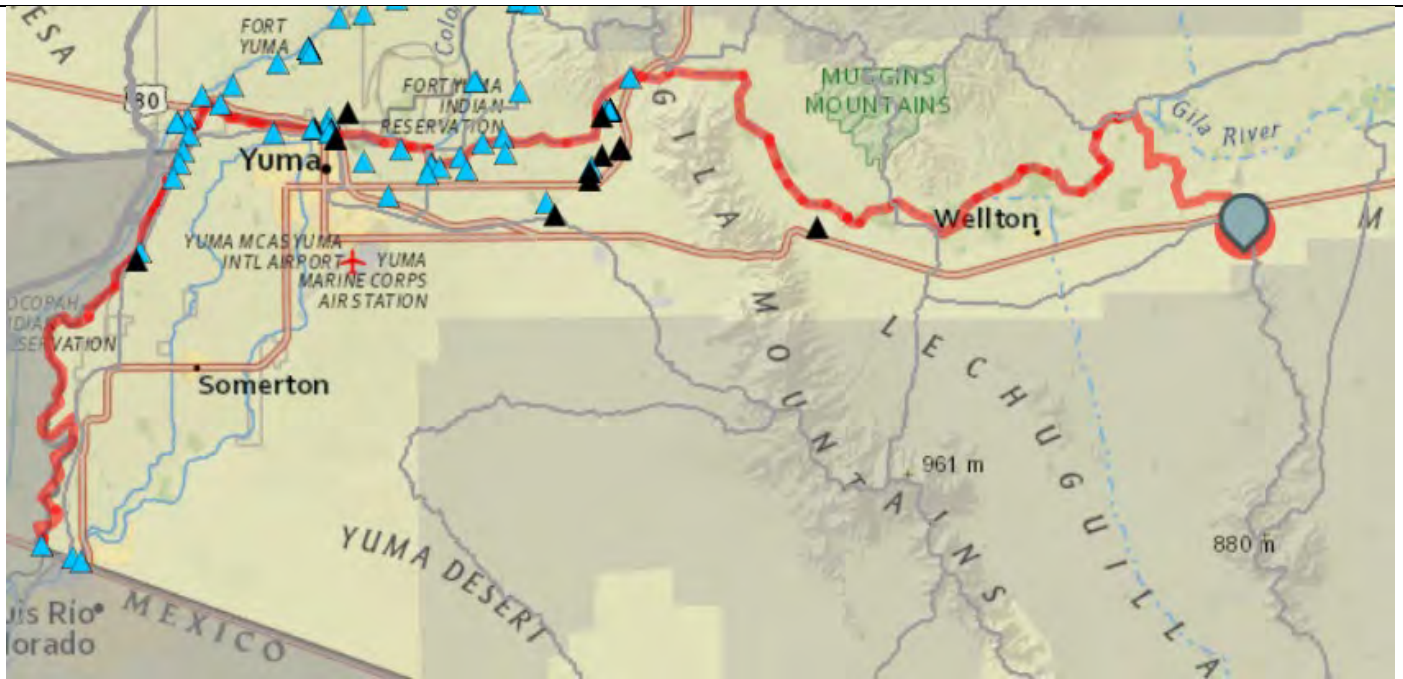
Figure 2. USGS Raindrop Tool incorrectly showing connectivity to the Gila River and then on to the Colorado River.

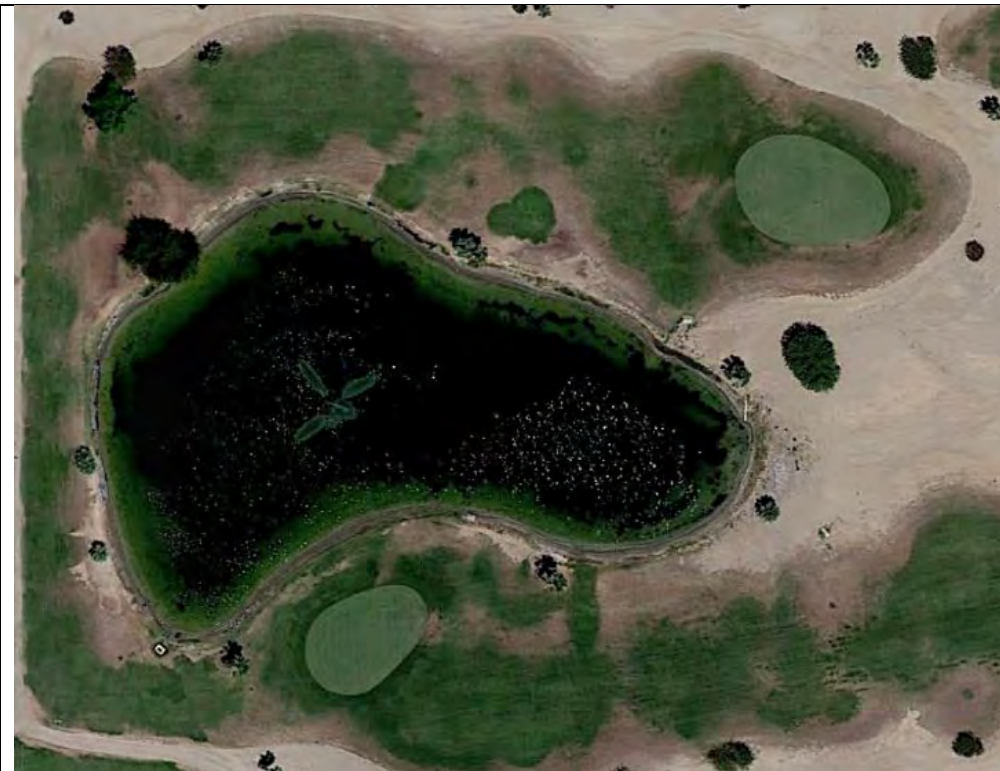
Figure 1. Google Earth imagery showing Wellton Pond 2 located within Butterfield Golf Course. There are no visible channels or outlets present.

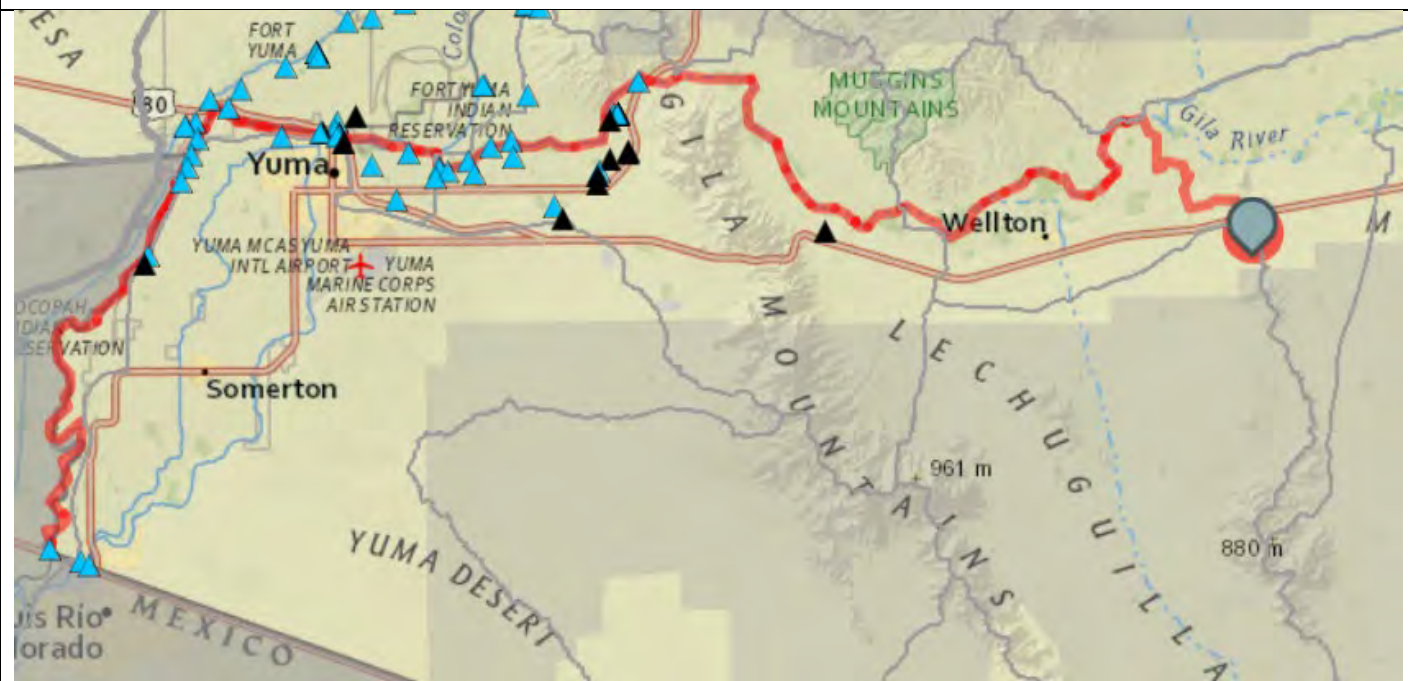
Figure 2. USGS Raindrop Tool incorrectly showing connectivity to the Gila River and then on to the Colorado River.

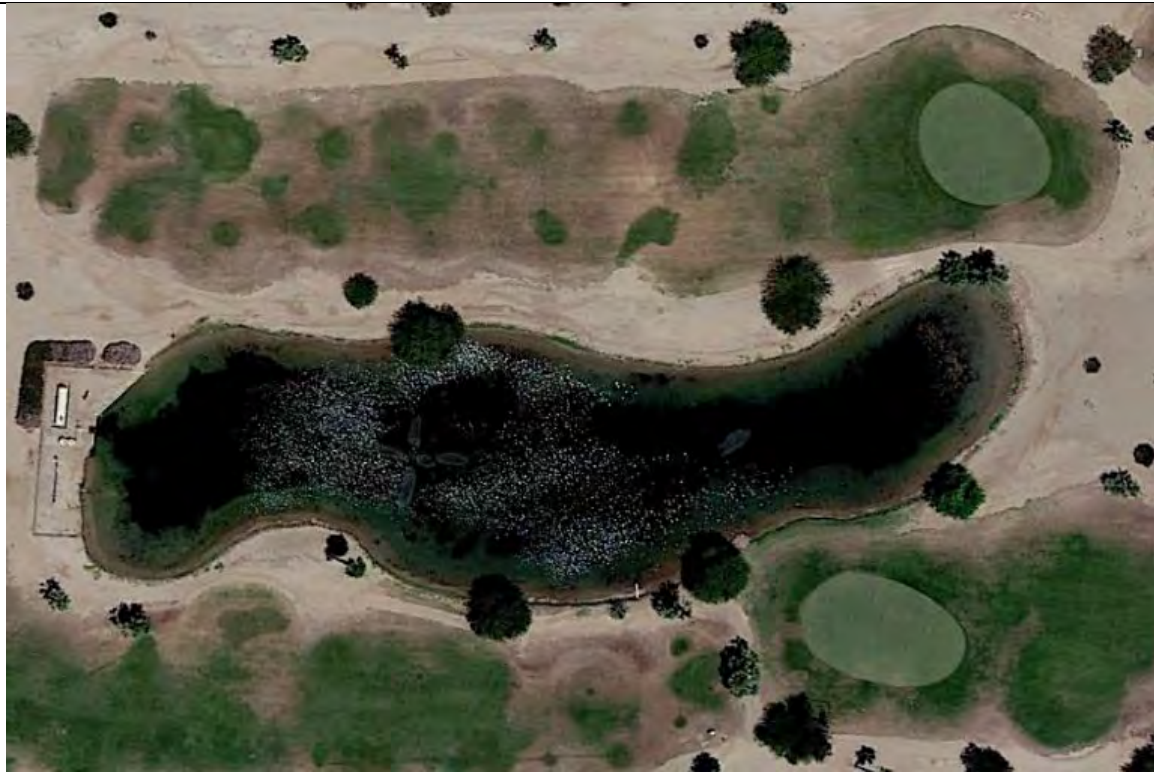
Figure 1. Google Earth imagery showing Wellton Pond 3 located within Butterfield Golf Course. There are no visible channels or outlets present.

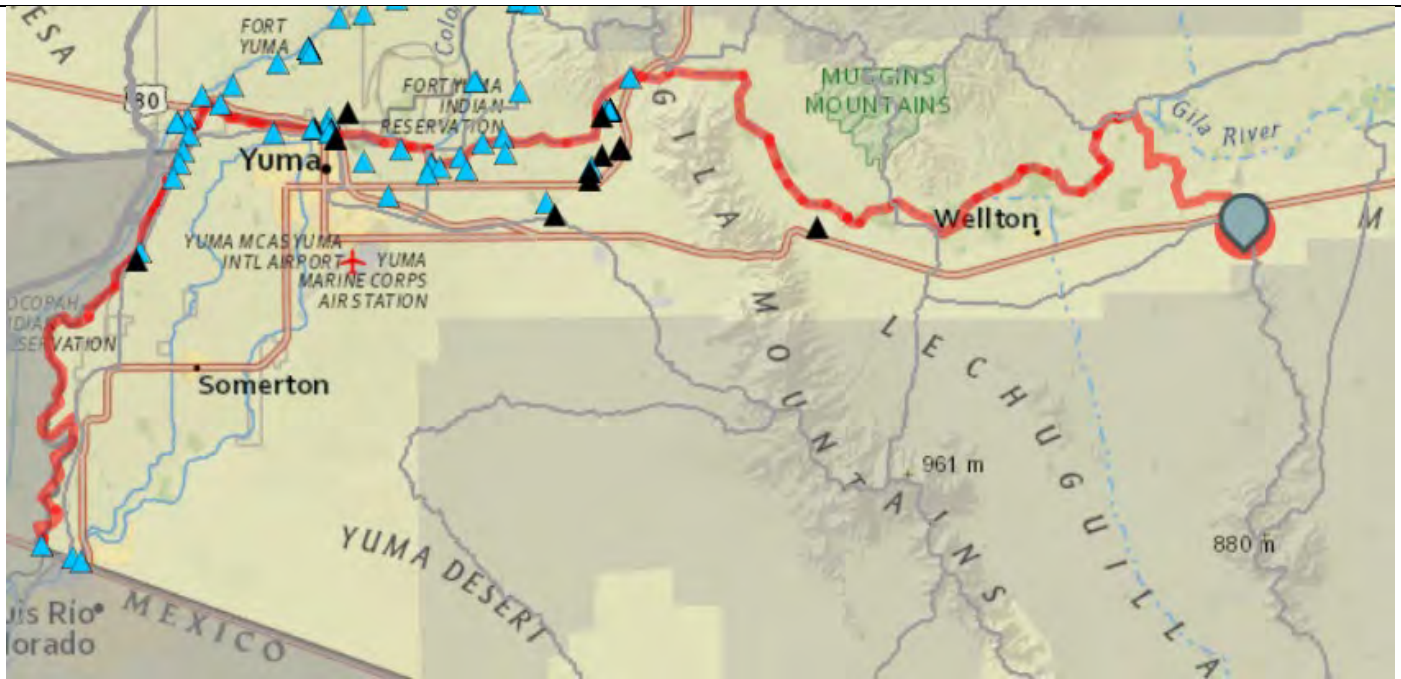
Figure 2. USGS Raindrop Tool incorrectly showing connectivity to the Gila River and then on to the Colorado River.

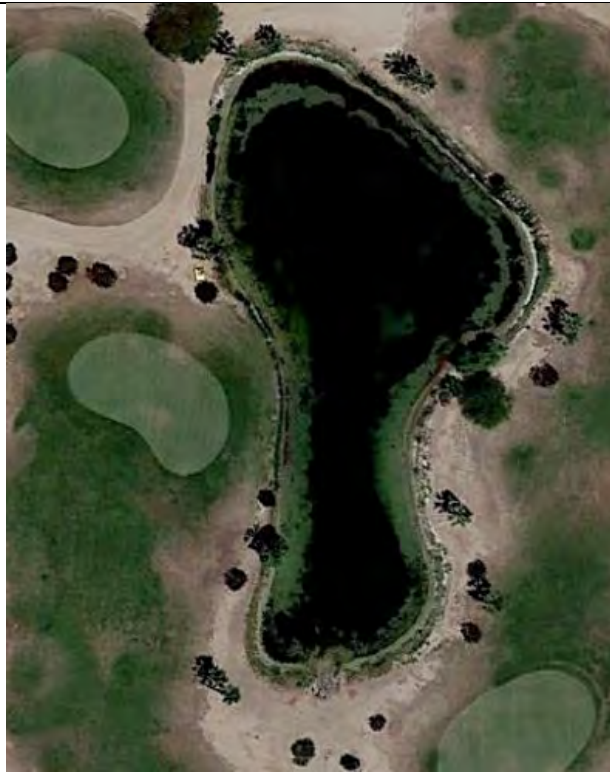
Figure 1. Google Earth imagery showing Wellton Pond 4 located within Butterfield Golf Course. There are no visible channels or outlets present.

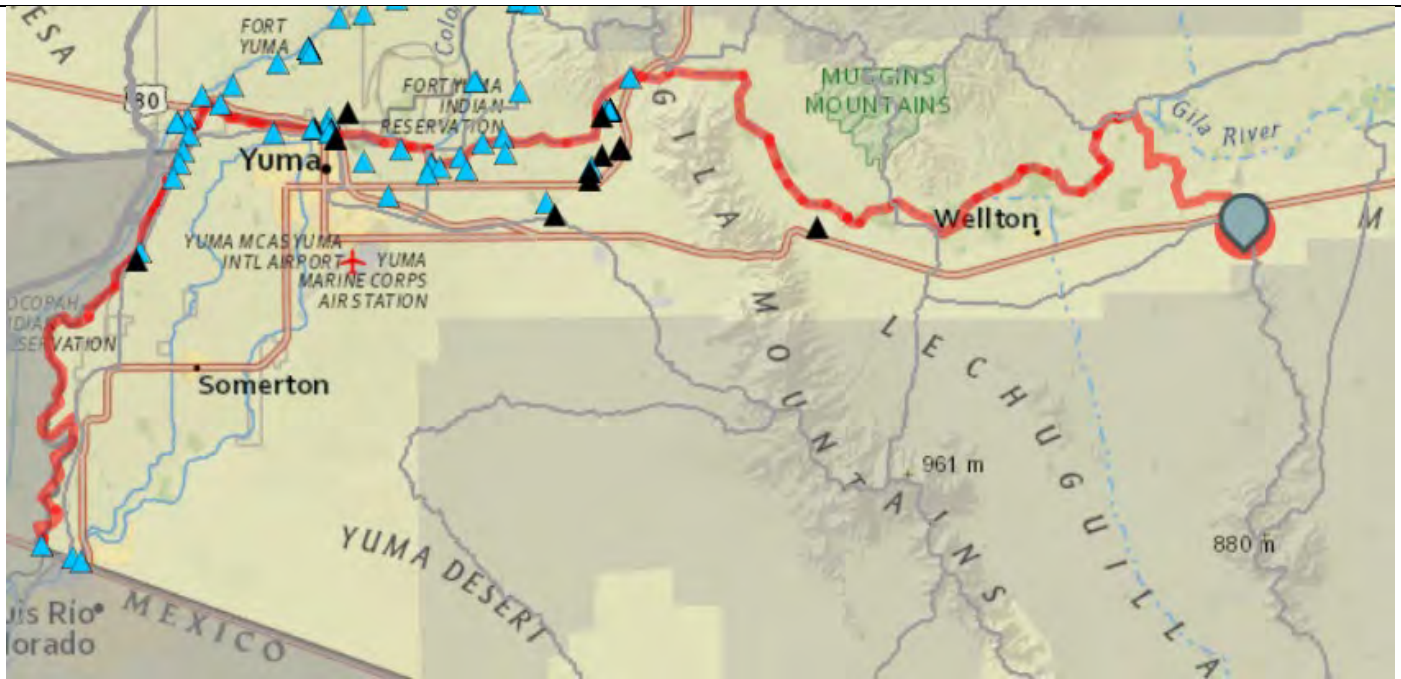
Figure 2. USGS Raindrop Tool incorrectly showing connectivity to the Gila River and then on to the Colorado River.

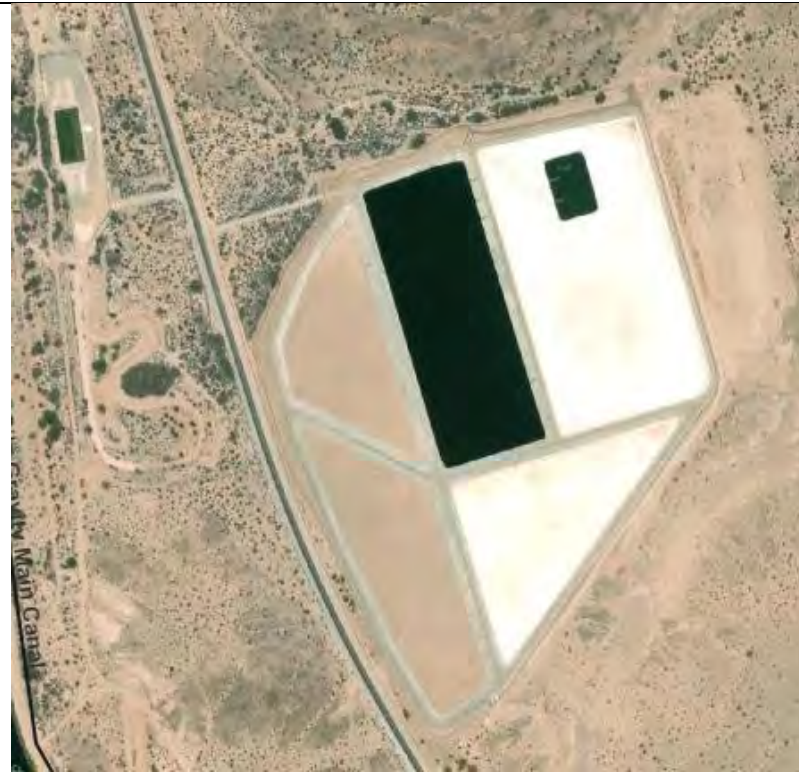
Figure 1. Aerial imagery of Yuma Proving Ground. The ponds are concrete lined and no outlets are visible.
